frostheave

a case study

by **E.J.Bowater**

“FJB Systems are specialists in the total design and project management of food processing plants and in particular chill & cold stores”

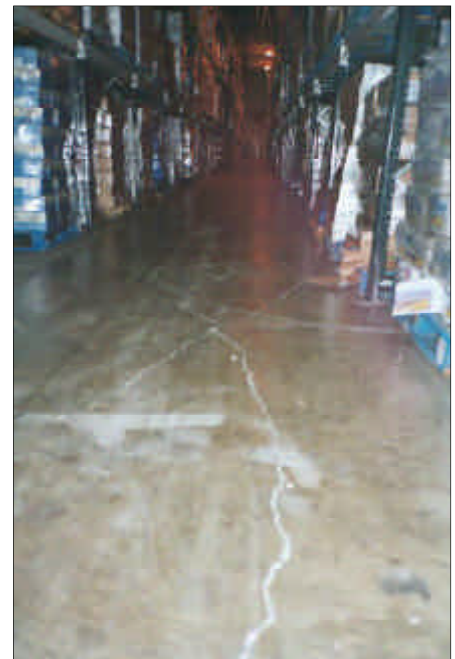
- Cracking of the working slab (see figure 2).
- Apparent (although not actual) subsidence of the perimeter walls of a store.
- Gradients within the store caused by the heave.
- Inability of mobile racking to move/premature wearing out of motors.
- Rising of internal support columns (if present).

Figure 2 - severe cracks in a cold store floor caused by frostheave

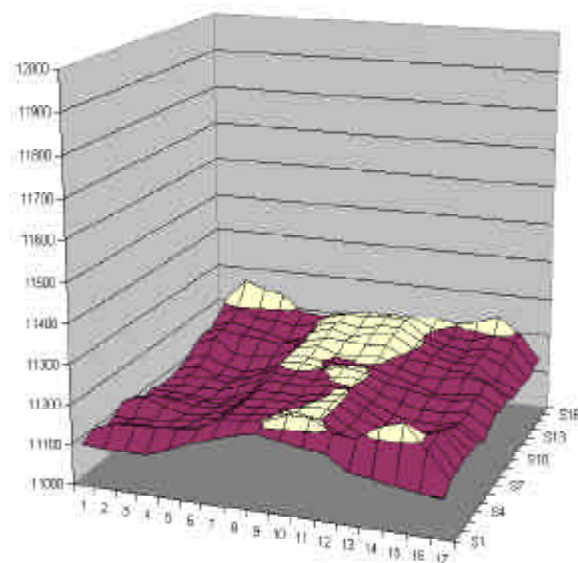
Figure 4 - surface contour map of a store with bad frostheave - here the worst areas have lifted by 200mm
