COLDSTORE INSULATION

panel degradation

by FJB Systems LLP
www.fjb.co.uk

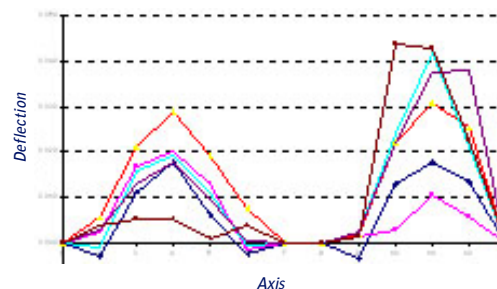
Figure 1

- iv) The increased weight of the panels will impose larger loads on the steel structure, often taking the structure beyond its design limits. (Figure 1 shows the results of a survey by FJB Systems into the flexing of a portal steel frame caused by ice-logged ceiling panels – in this case the structure would have collapsed if a significant snow load had been imposed).

Survey of Coldstore Support Steelwork

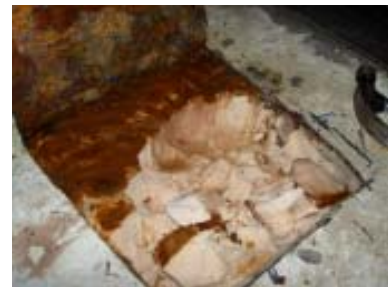
Core Sampling an 'ice-logged' panel

FJB Systems have found that correctly carried out thermographic surveys combined with core sampling can provide accurate predictions of which areas of insulation require renewal and which areas can remain. By taking this approach, the owner/operator of a large store can save many hundreds of thousands of pounds by only replacing the damaged panels. Figure 2 shows the results of a particular store surveyed by FJB Systems and which illustrates the areas requiring replacement (approximately 30% of the total ceiling area). Prior to contacting FJB Systems, the Client had been provided with numerous quotations from Insulation Contractors recommending that the whole ceiling be replaced.

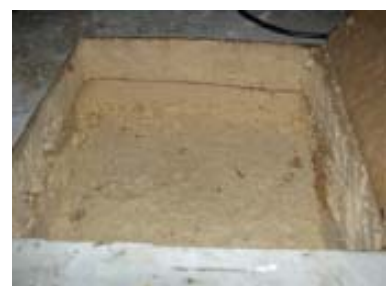
Core Sampling a 'dry' panel

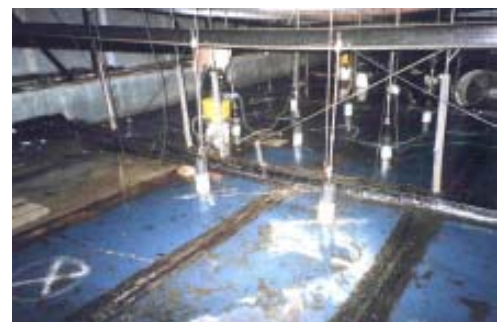
A waterlogged roof void

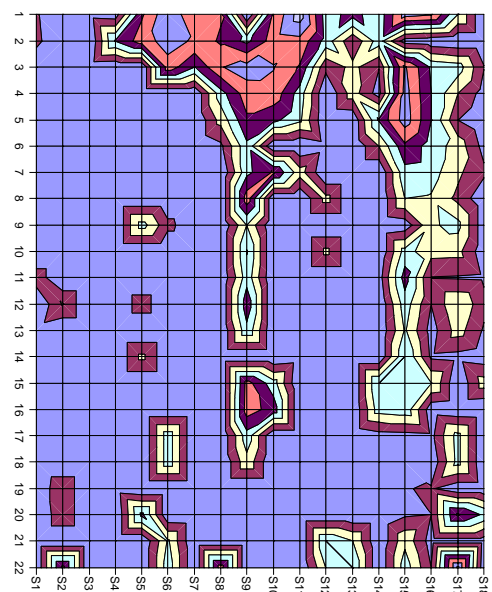
Figure 2
Thermographic Survey Results
