## CASE STUDY - COLDSTORE INSULATION - panel degradation

A common problem within the cold storage industry is the degradation of the insulation sandwich panels, which form the cold storage envelope. FJB Systems have been called in to many sites where clients have been experiencing a variety of problems and this paper aims to illustrate the common causes of these problems, combined with illustrations of case studies.

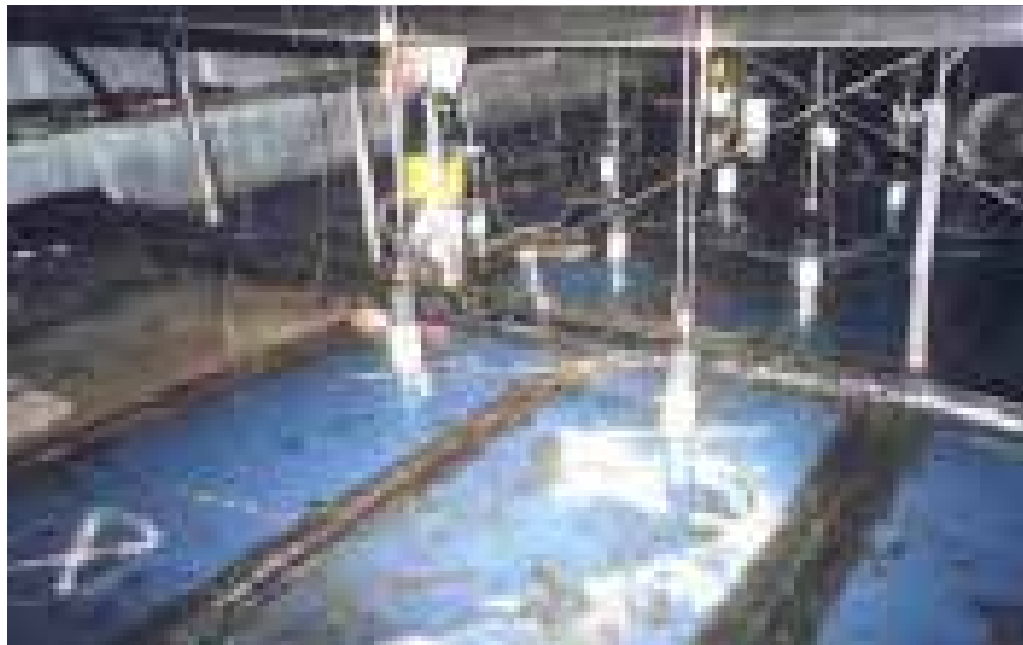
4. The increased weight of the panels will impose larger loads on the steel structure, often taking the structure beyond its design limits. (Figure 1 shows the results of a survey by FJB Systems into the flexing of a portal steel frame caused by ice-logged ceiling panels – in this case the structure would have collapsed if a significant snow load had been imposed).

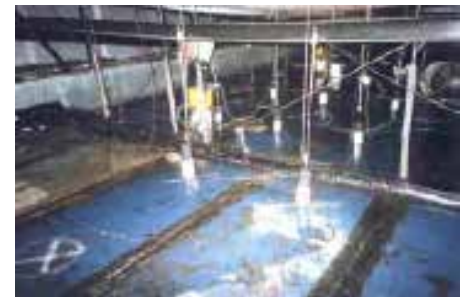
*A waterlogged roof void*

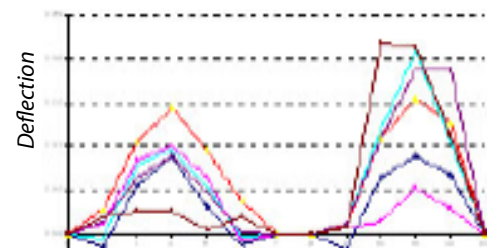
*Figure 1*

*Survey of Coldstore Support Steelwork*

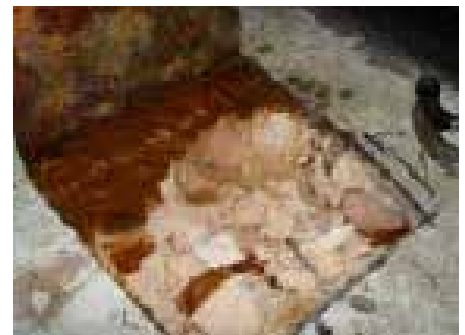
*Core Sampling an 'ice-logged' panel*

In actual case studies, FJB Systems have found that panel weights can increase up to 30 times their original values just by virtue of prolonged exposure to these adverse elements. In situations like these, even curing the causes of the problems will not be sufficient to rectify the situation and the panels will need to be replaced.

FJB Systems have found that correctly carried out thermographic surveys combined with core sampling can provide accurate predictions of which areas of insulation require renewal and which areas can remain. By taking this approach, the owner/operator of a large store can save many hundreds of thousands of pounds by only replacing the damaged panels. Figure 2 shows the results of a particular store surveyed by FJB Systems and which illustrates the areas requiring replacement (approximately 30% of the total ceiling area). Prior to contacting FJB Systems, the Client had been provided with numerous quotations from Insulation Contractors recommending that the whole ceiling be replaced.

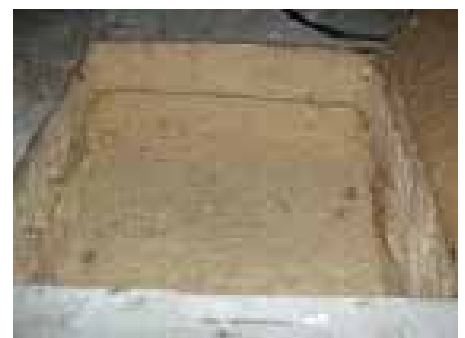
*Core Sampling a 'dry' panel*
