CASE STUDY FROSTHEAVE

The Case Study

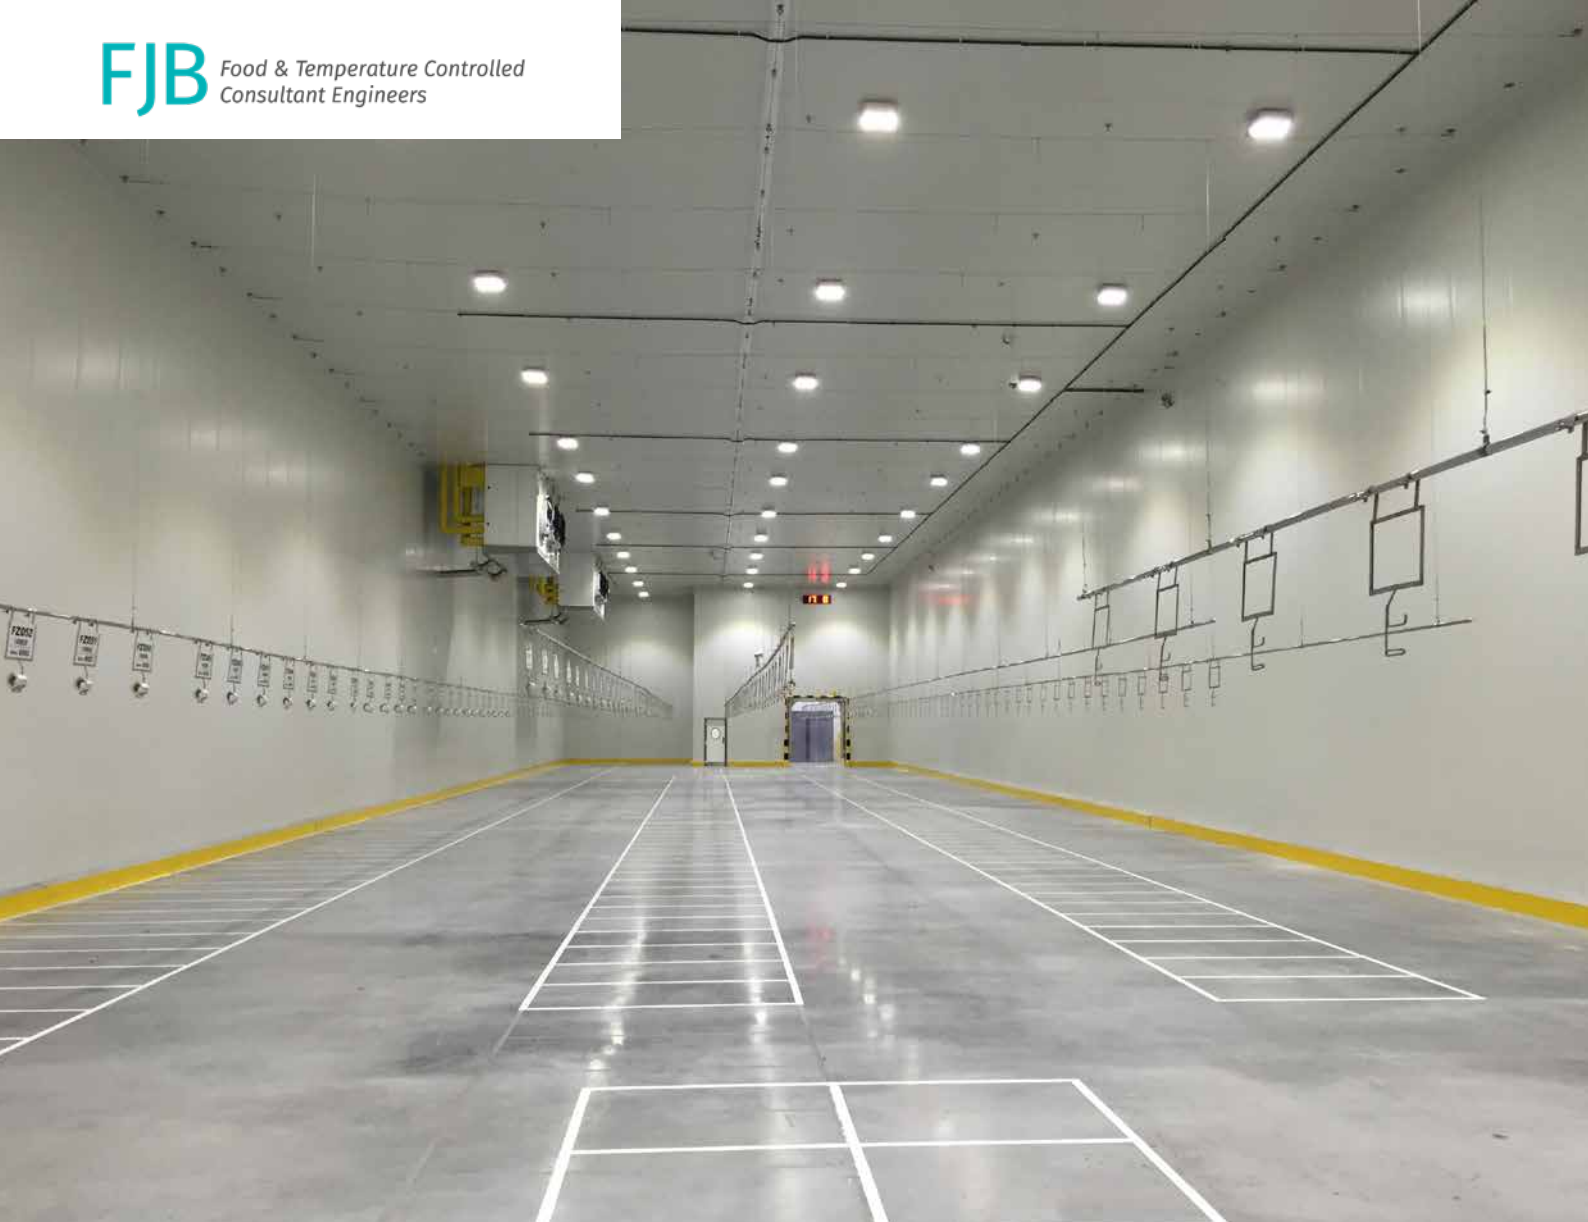
The store measured approximately 40 (L) x 30 (W) x 8 (H) metres and had operated continuously at -25degC for three years prior to any problem being perceived. The store was fully installed with mobile racking and the first sign of a problem that the management noticed was that the motors on the mobile racks were burning out prematurely. Later, cracking was seen on the floor surface and only later still did the rise in floor level become obvious. At this point the company's insurers were called in and later FJB Systems. The largest rise of the floor at the worst point of the heave was then found to be 120mm (see figure 3).

In this instance, once the cause of the heave had been identified, FJB Systems sought the most simple, economical and effective solution for the problem. Their recommendation was to re-wire the second heater mat control system to be permanently on. The permanent heat would, over time, melt the sub-soil ice build up.

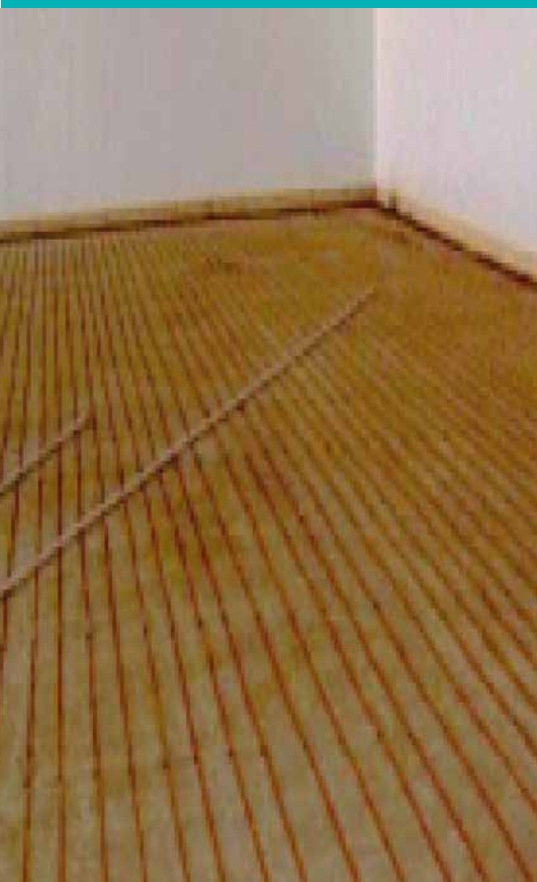
To overcome frostheave, a cold store floor is typically constructed in the following manner (see figure 1); the sub-soil is compacted followed by a suitable consolidated hardcore and blinding on which a reinforced concrete sub-floor is laid. When cured, an electrical heating mat or alternatively a piping system is clipped onto this concrete sub-floor and then covered with 50mm of sand/cement screed. This screed is then covered with a heavy gauge visqueen sheet with overlapped taped joints to form a positive vapour barrier. On top of this vapour barrier, two to three layers of heavy duty insulation slabs are laid to provide the floor insulation (in the past 30 years it has been normal in the UK to utilise 150mm total thickness of high density styrofoam as the insulant and with some older stores, there is the possibility of high-density cork being used). The final phase of construction is the laying of the final concrete working floor slab, which should be designed to safely withstand the equipment required for the room operation, such as racking and reach trucks.

In this way, the cold store floor is insulated by means of thick layers of floor insulation, and the purpose of the underfloor heating system is to replace the relatively small amount of heat being removed through the insulated floor into the cold store room. Heat will always flow from warm to cold. It is usual for the sub-floor temperature to be maintained at about +4degC by the heating system. Usually this temperature is monitored by a number of independent temperature probes. Without this process of adding heat, the underfloor temperature would fall and the ground will ultimately freeze. The resultant ice expansion creates substantial forces which will push the floor slab upwards (hence frostheave). This upward motion can continue for years as the sub-soil ice increases in volume and goes deeper. In some instances floor levels have been raised by feet, not inches.
